PERTH & METRO

**PRE-PURCHASE
PROPERTY INSPECTION
(BUILDING)**

AS:4349.1-2007

01 Sample Address at Sample St WA 6000

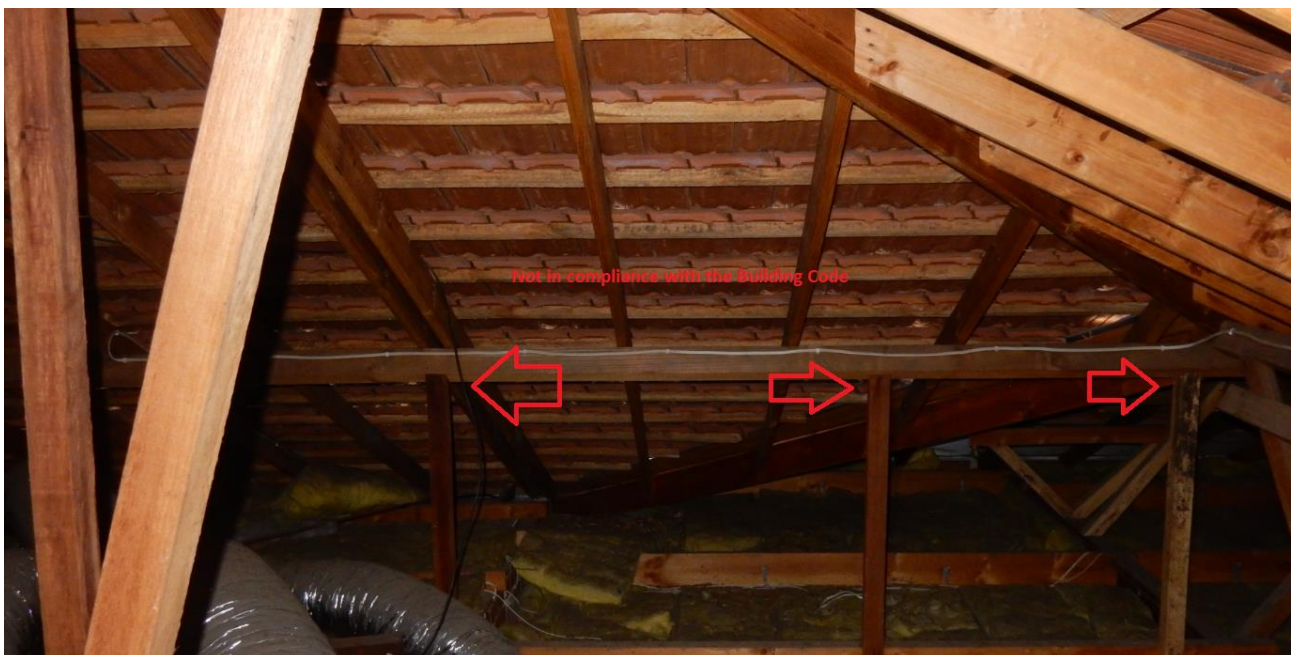
1/ Roof Void / cuts used to for the struts are not compliance the building code to support the under purling.

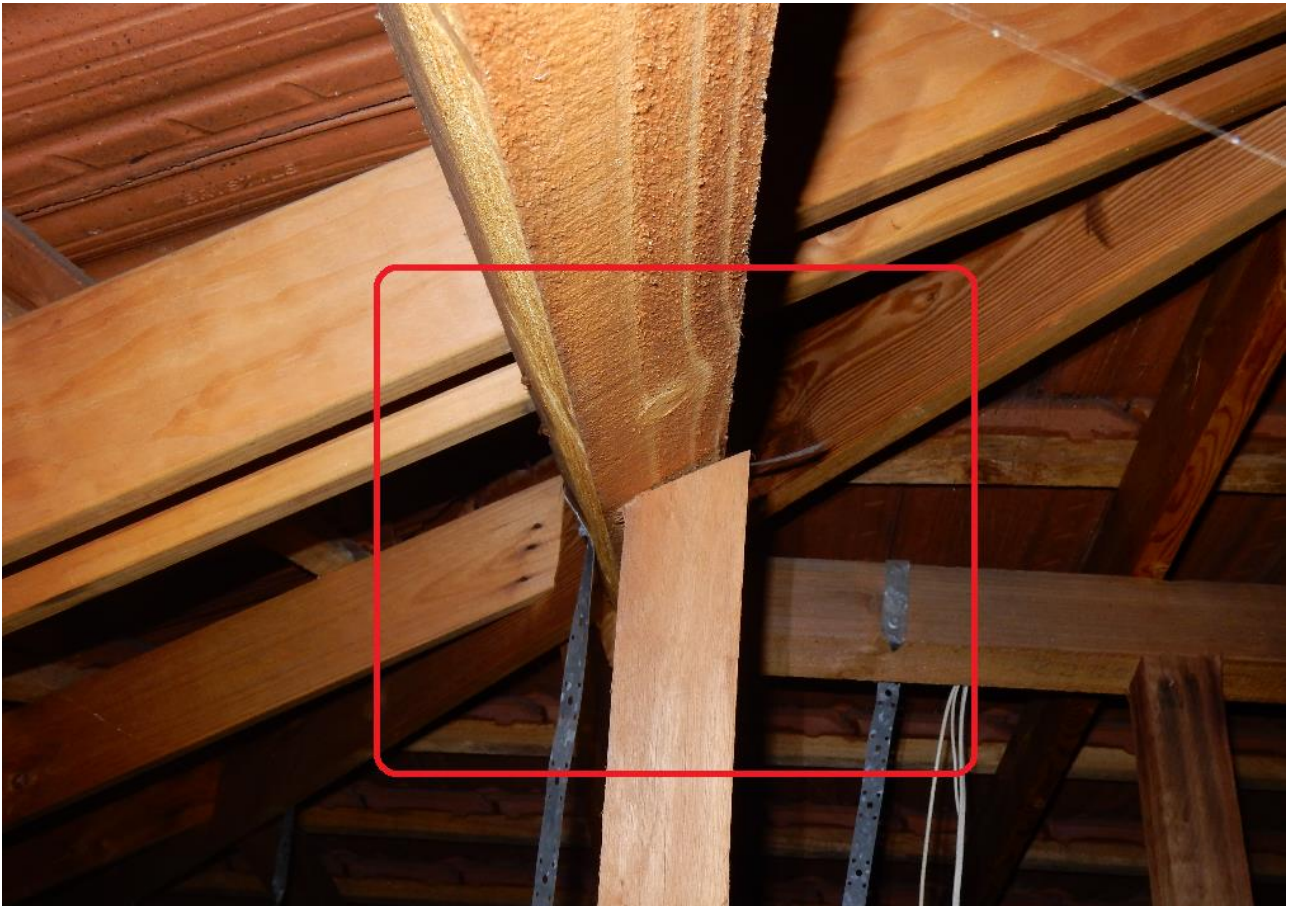
2/ Roof Void / cuts used to for the struts are not compliance the building code to support the under purling.

Because the install of the air conditioning unit the under purling is now slipping away from the strut.

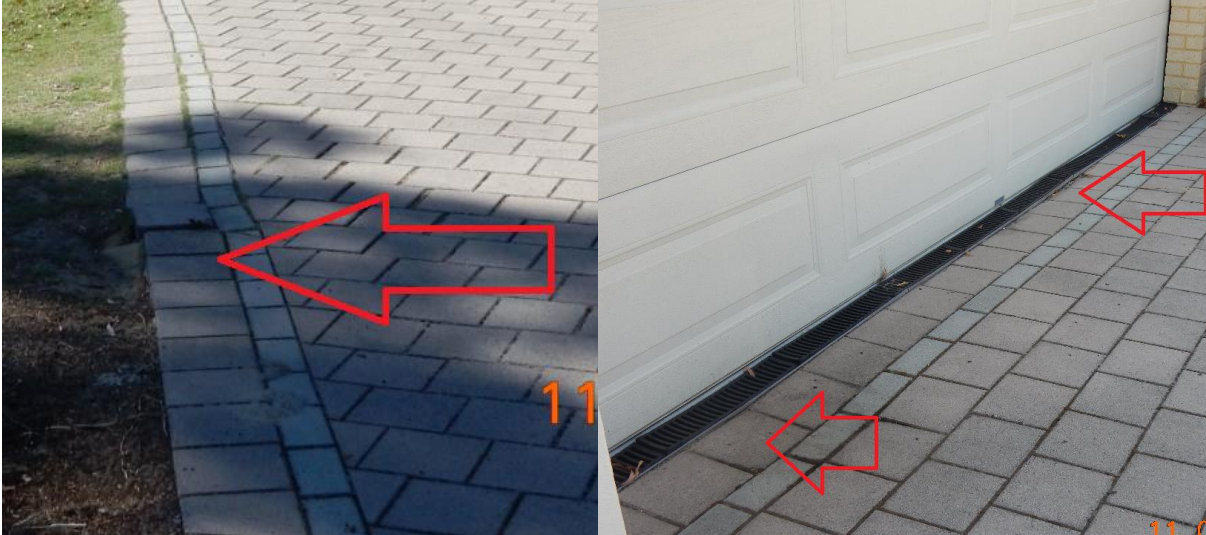
1/ Undulating pavers and or concrete joints can be a trip hazard

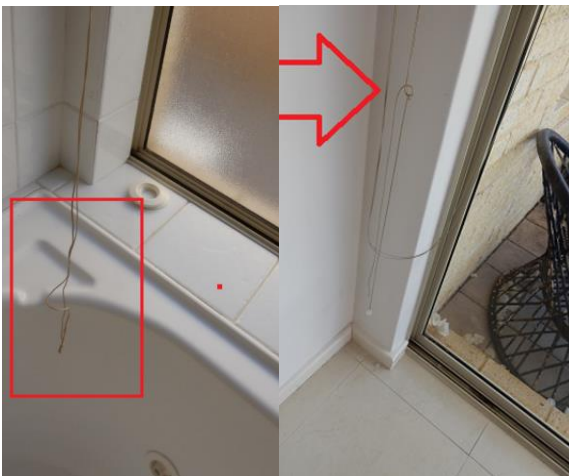
Window and door venetians, blinds and or curtain cords can be a choke hazard if left dangling in view of toddlers.

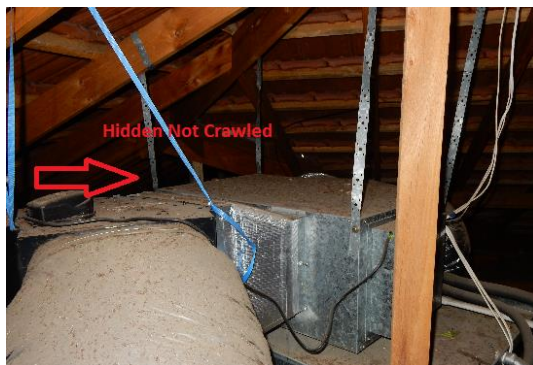
- a. To sections of the roof loft:
- b. Hindered access to: Roof Areas

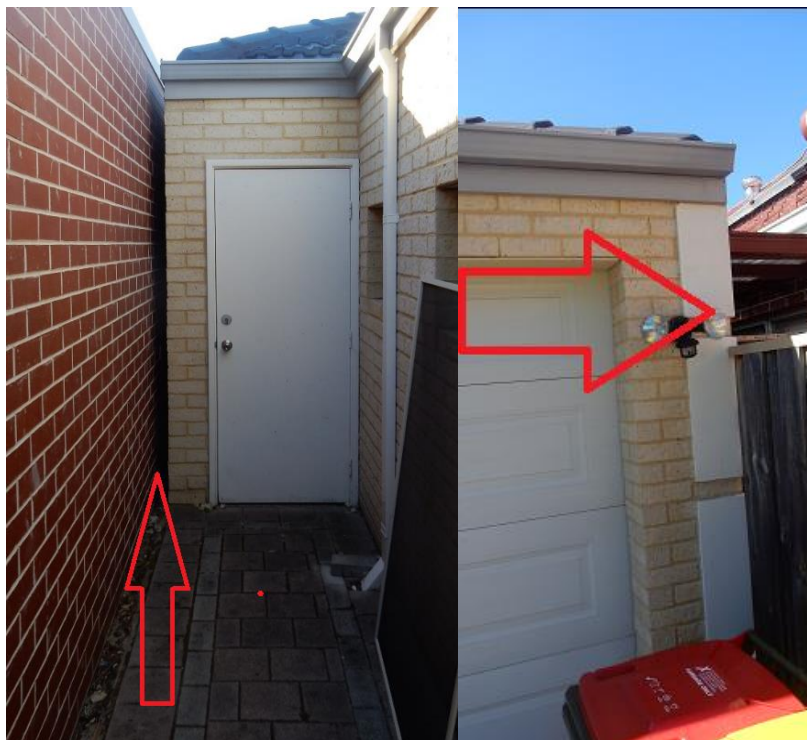
- c. Boundary Wall

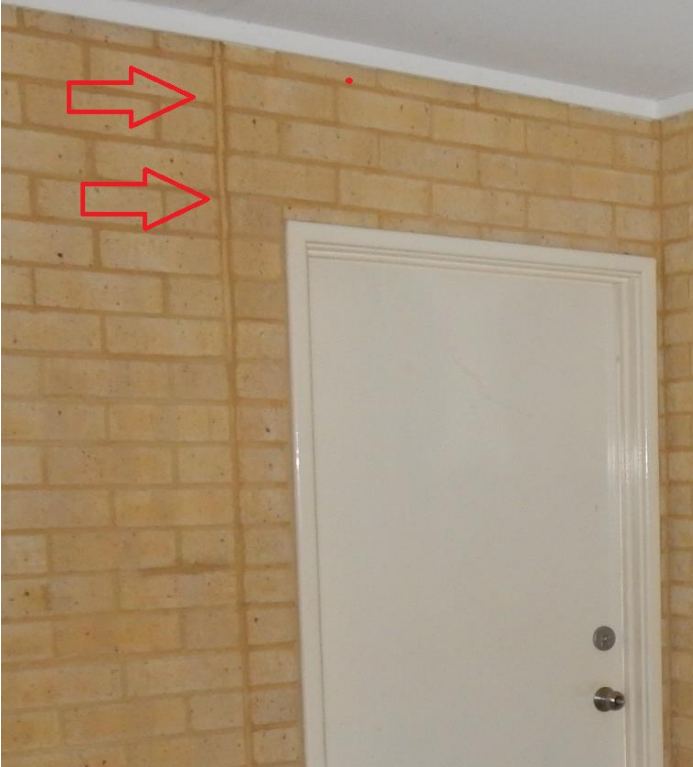
Garage Wall been constructed by brickie in a unlike workmanship matter

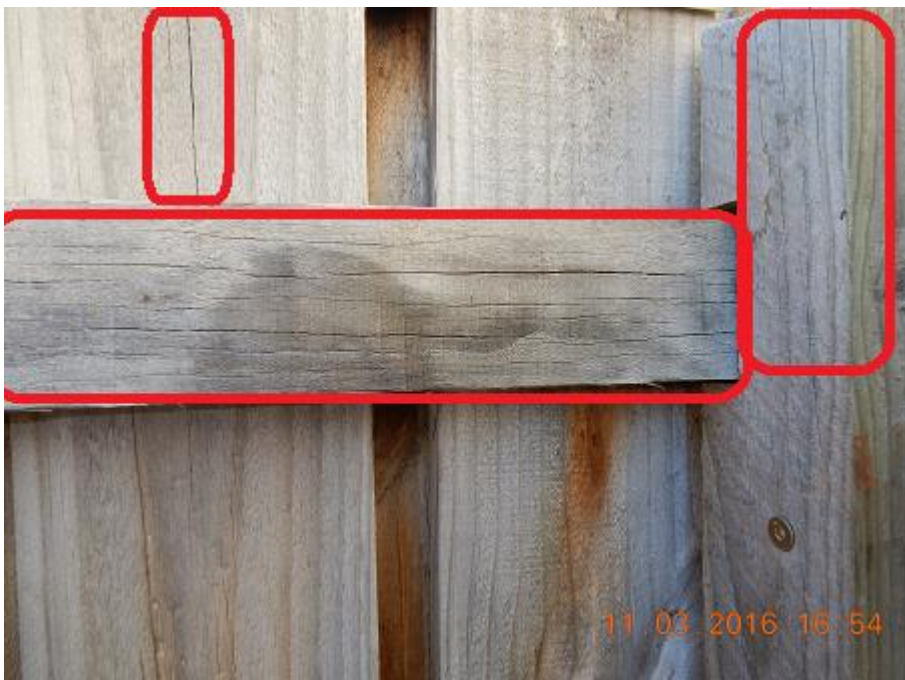
Location 1: *Wooden fence*

Yes fungal decay was found at the time of this inspection.
