Pest Be Gone Solutions

Timber Pest inspection Report

(AS:4349.3-2010)

Sample Report
(address)

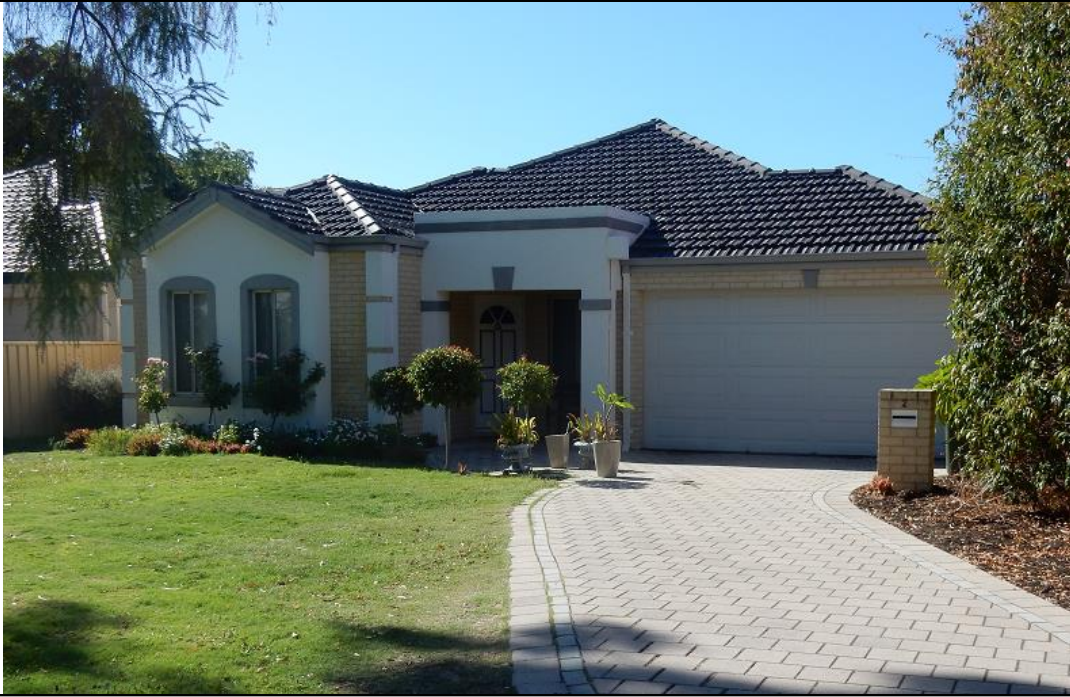
Front Elevation of the Inspected Property

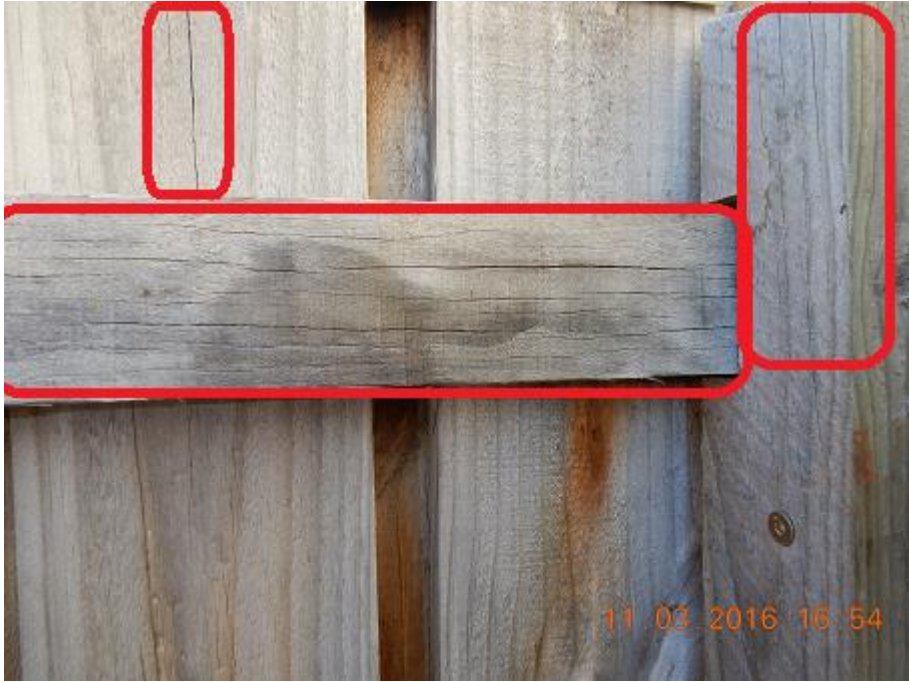
6.33 Was evidence of wood decay fungi (wood rot) found? **Yes fungal decay was found at the time of this inspection.**

Location 1: **Wooden fence**

We claim no expertise in building therefore if any evidence or damage has been reported above then you must have a licensed builder and similar expert determine the full extent of damage and the estimated cost of repairs or timber replacement.

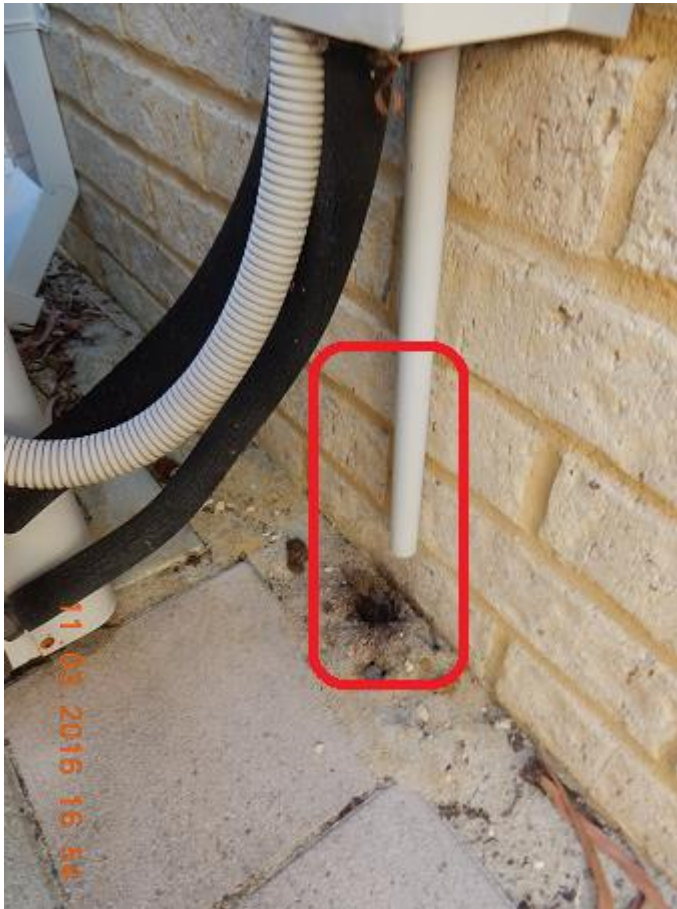
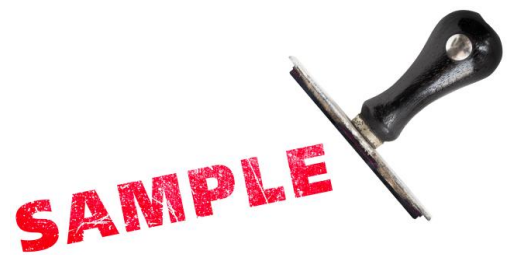
6.38 **Hot Water services** and **Air Conditioning units** that do release water alongside or near external walls need to be connected to a drain. If this is not possible then their water outlet needs to be piped several meters away from the building as this is highly conducive to termites.

Is there a need for this work to be carried out? **Yes**

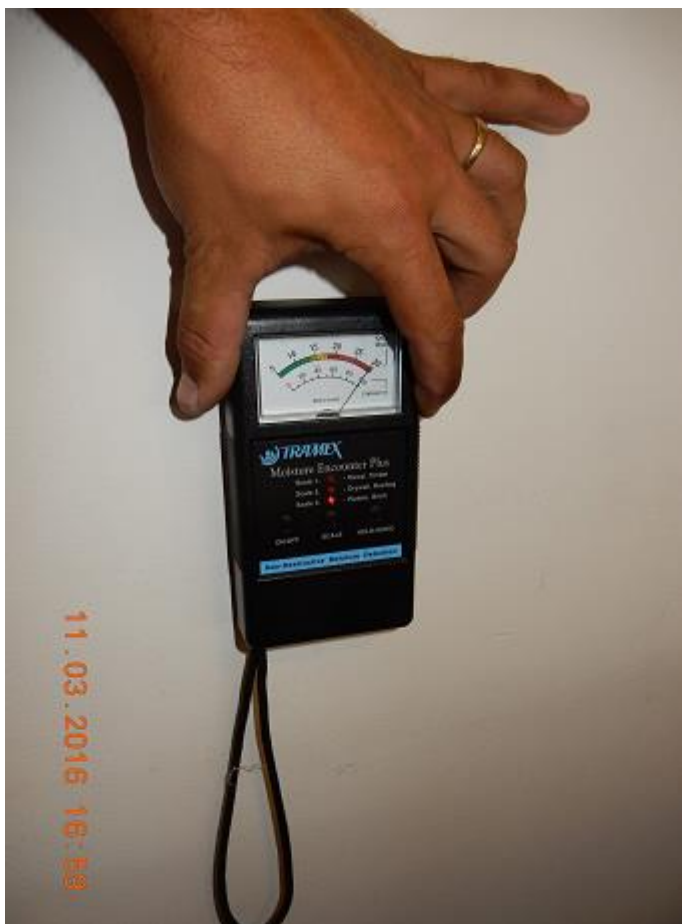
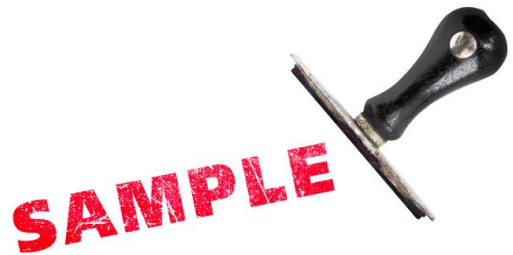
At the time of the inspection: **Yes, high moisture readings were found at the time of the inspection.**

Location 1: **Lounge room wall behind shower**

If high moisture was reported then you must have a building expert investigate the moisture and its cause and determine the full extent of damage and the estimated cost of repairs.

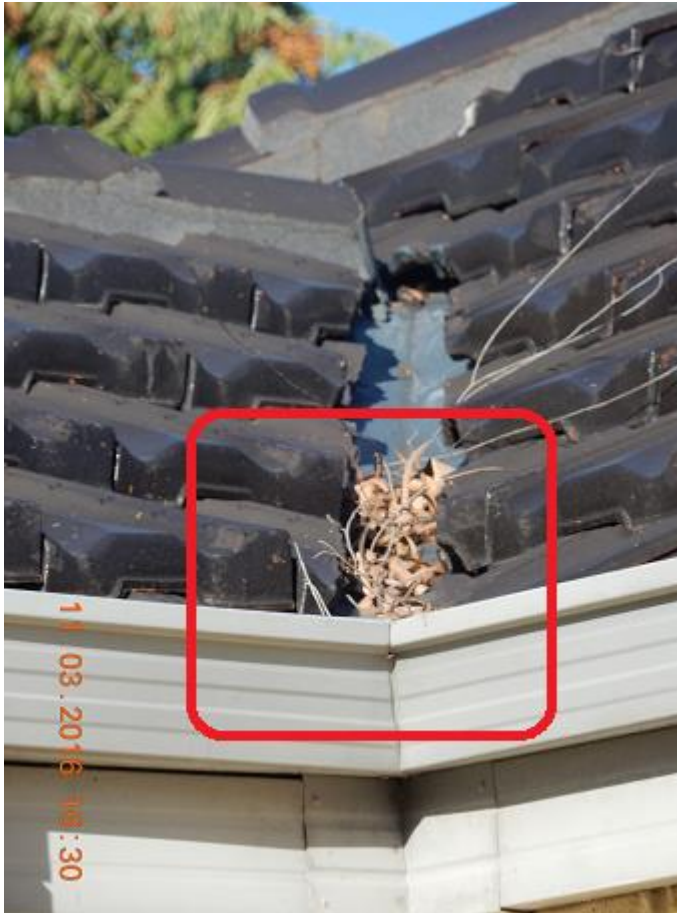
Inadequate to rear yard

- Guttering has leaf/ vegetation content

Where drainage is considered inadequate a plumber & drainer, a licensed builder or other building expert must be consulted.

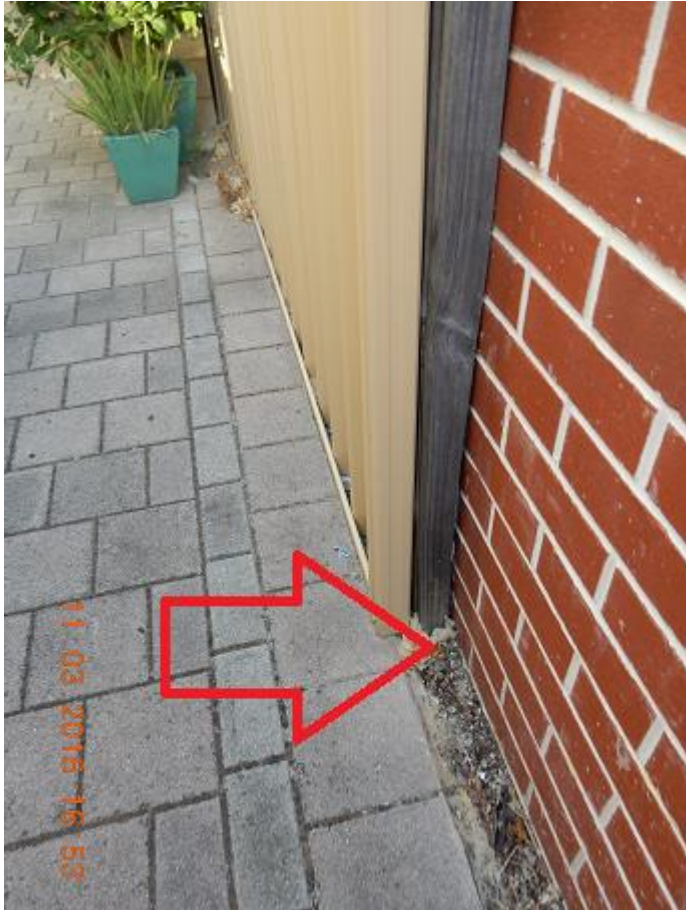
Was evidence of untreated or non-durable timber used in a hazardous environment found: **Yes.**

Location 1: **Wooden post**

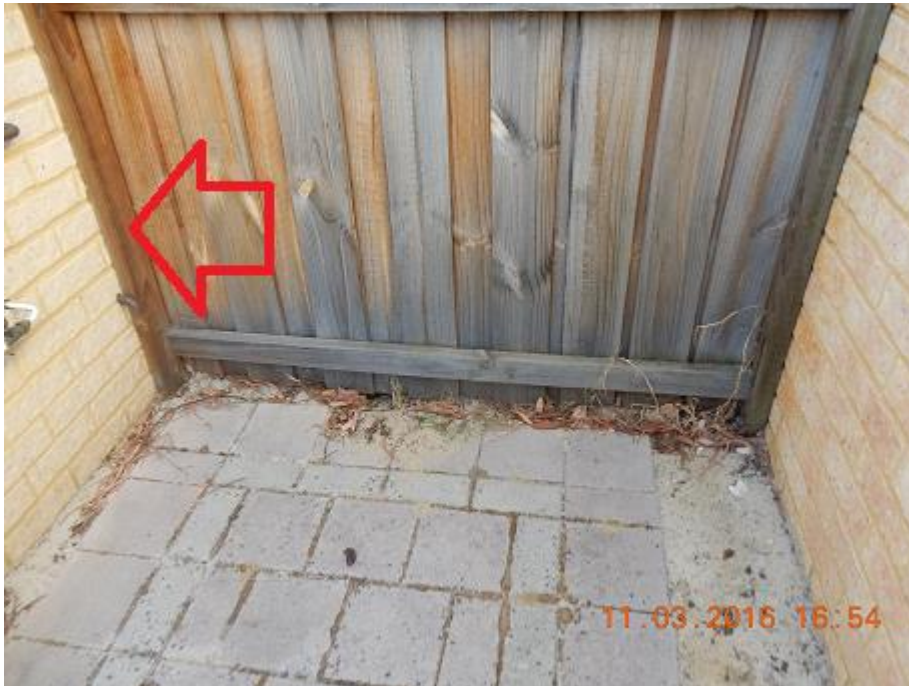
Location 2: Wooden fence
